**Flood Control Project Maintenance
Levee Inspections**
LMA District Cover Sheet
Spring 2018 Levee Inspection Results

Levee District No. 0001 (Sutter County)

Waterway			Bank	Unit Miles
Unit No. 01 Feather River			Right	16.11
	Spring (March - May)	Summer (June - August)	(September - November) Fall	Winter (December - February)
Unit Maintenance Rating (Fall Only)				
Date of Inspection	3/13/2018 - 3/13/2018			
DWR Inspector	Sterling York			
Accompanied By	Andrew Stresser LD0001S

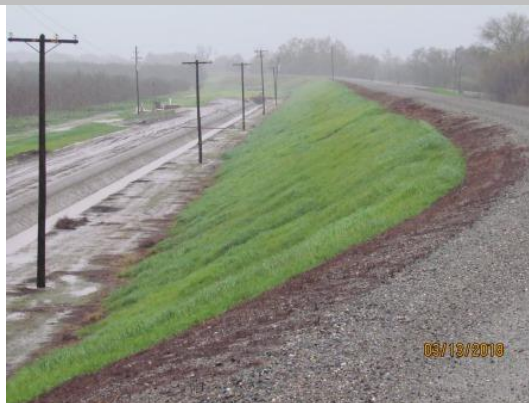
Photo 1 of 3 : SP_2018_LD0001S_433_16_20180319_00055.jpg

View looking upstream landside of the well maintained annual vegetation at Levee Mile 0.02, Spring 2018.

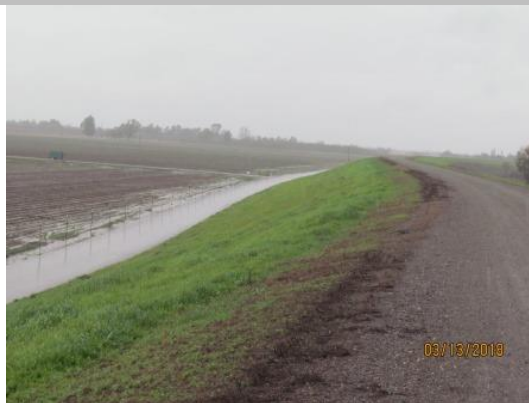
Photo 2 of 3 : SP_2018_LD0001S_433_16_20180319_00056.jpg

View looking upstream landside of the well maintained annual vegetation at Levee Mile 16.16, Spring 2018.

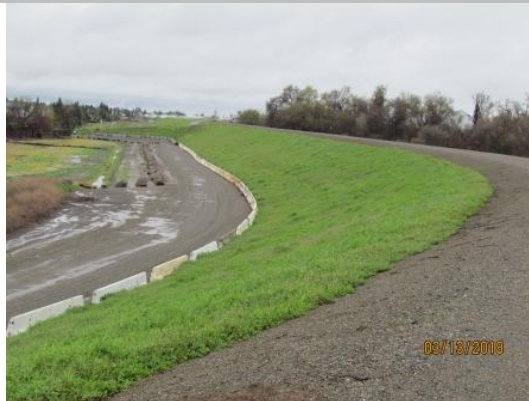
Photo 3 of 3 : SP_2018_LD0001S_433_16_20180319_00057.jpg

View looking upstream landside of the well maintained annual vegetation at Levee Mile 10.48, Spring 2018.

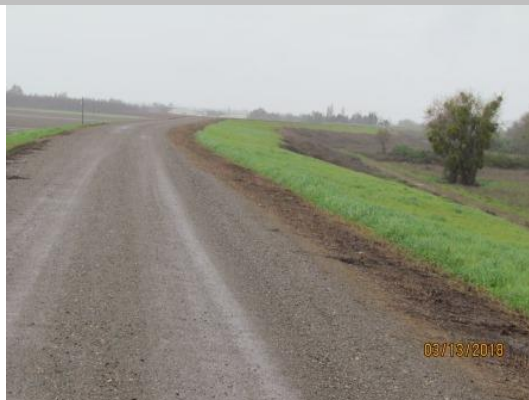
Photo 1 of 3 : SP_2018_LD0001S_433_17_20180319_00059.jpg

View looking upstream waterside of the well maintained annual vegetation at Levee Mile 0.02, Spring 2018.

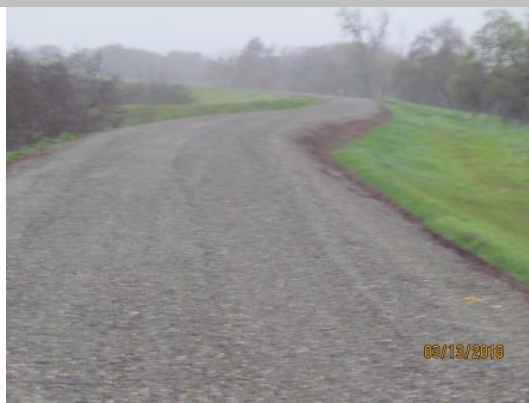
Photo 2 of 3 : SP_2018_LD0001S_433_17_20180319_00058.jpg

View looking upstream waterside of the well maintained annual vegetation at Levee Mile 6.24, Spring 2018.

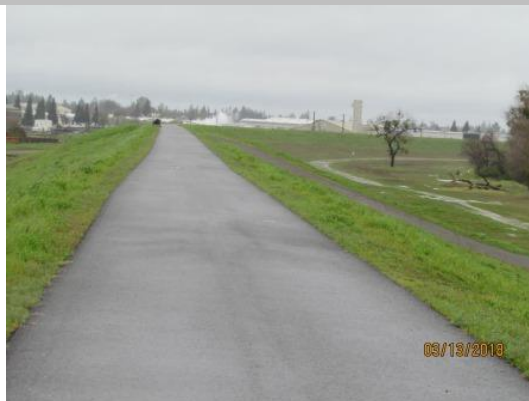
Photo 3 of 3 : SP_2018_LD0001S_433_17_20180319_00060.jpg

View looking upstream waterside of the well maintained annual vegetation at Levee Mile 10.92, Spring 2018.

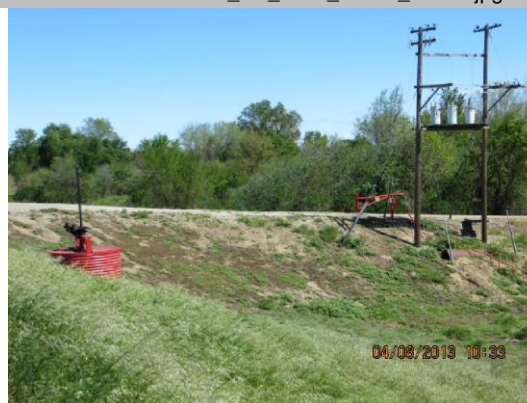
Photo 2 of 3 : UCIP_SP_2018_41624_18768.jpg

Comment Code						
Inspector Comment						
FS_ID:41624 DS_ID:18653 EP_NO: 4667 Repair Type: Non-Urgent Crossing Status: Found UCIP Comments: Abandoned crossing. Concrete box on both sides found. Pipe remainings are found on WS. FIELD_STRUCT_DESC: *ABANDONED* 36-inch steel irrigation pipe through the levee, 10 feet below the crown. Concrete box found on each side. Pipe remains found on the waterside (WS) after the removal of 40 feet of 36-inch steel pipe from a spur levee and 20 feet of 36-inch steel pipe from the landside (LS) slope of the Feather River Levee. (Plans for removal of a portion and filling with concrete a portion of an abandoned 36-inch steel pipe through the levee authorized under Permit No. 4667, 1964 - Levee District No. 1 of Sutter County [LD0001S]). [Additional Reference(s): USACE Sacramento O&M Manual 144, August 1955, (Station 735+57)]. FS Date: 4/12/2013

WS- abandoned pipe near power pole (right)

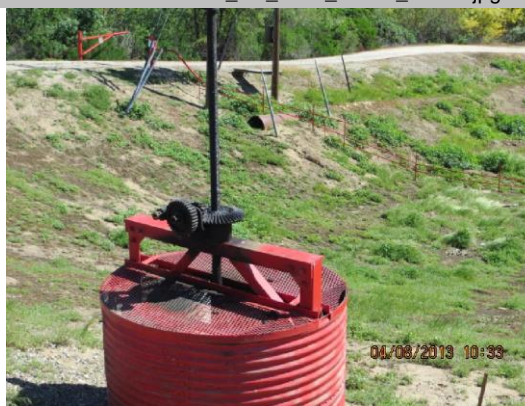
Photo 3 of 3 : UCIP_SP_2018_41624_18767.jpg

Comment Code						
Inspector Comment						
FS_ID:41624 DS_ID:18653 EP_NO: 4667 Repair Type: Non-Urgent Crossing Status: Found UCIP Comments: Abandoned crossing. Concrete box on both sides found. Pipe remainings are found on WS. FIELD_STRUCT_DESC: *ABANDONED* 36-inch steel irrigation pipe through the levee, 10 feet below the crown. Concrete box found on each side. Pipe remains found on the waterside (WS) after the removal of 40 feet of 36-inch steel pipe from a spur levee and 20 feet of 36-inch steel pipe from the landside (LS) slope of the Feather River Levee. (Plans for removal of a portion and filling with concrete a portion of an abandoned 36-inch steel pipe through the levee authorized under Permit No. 4667, 1964 - Levee District No. 1 of Sutter County [LD0001S]). [Additional Reference(s): USACE Sacramento O&M Manual 144, August 1955, (Station 735+57)]. FS Date: 4/12/2013

WS- abandoned pipe near power pole (top)

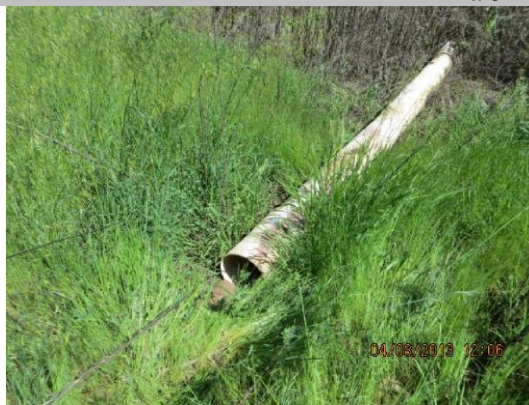
Photo 2 of 3 : UCIP_SP_2018_11383_18781.jpg

LM Start	2.21	Rating **	M	Issue No.	39
LM End	2.21	Issue Type +	Ma	Location *	
Category	Supplemental			GPS Latitude/Longitude	
				Start	End
Item	DWR UCIP LMA Responsibility			38.982135 °	38.982135 °
				-121.591974 °	-121.591974 °
DWR ID					
Comment Code					
Inspector Comment					
FS_ID:11383 DS_ID:17915 EP_NO: N/A Repair Type: Non-Urgent Crossing Status: Found UCIP Comments: Siphon breaker cap missing. Sump pump and gate valve at landward toe not found may be due to dense vegetation. FIELD_STRUCT_DESC: 8-inch coated steel pipe of an unknown purpose through the levee, 4.6 feet below the crown. Siphon breaker in a corrugated metal pipe (CMP) riser on the landside (LS) slope. [Additional Reference(s): DWR Levee Log, 2005. USACE Sacramento O&M Manual 144, August 1955, (Station 638+07)]. FS Date: 4/12/2013

WS-a disconnected pvc pipe on levee slope

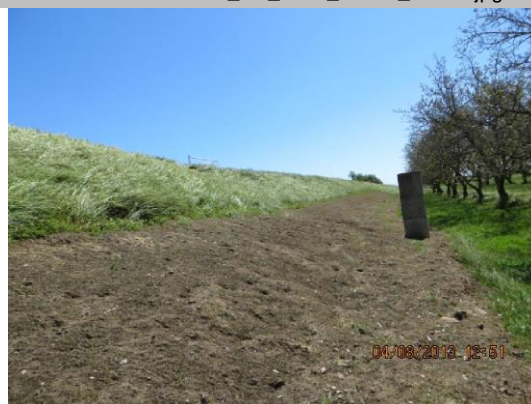
Photo 1 of 3 : UCIP_SP_2018_41787_18793.jpg

Comment Code					
Inspector Comment					
FS_ID:41787					
DS_ID:18667					
EP_NO: N/A					
Repair Type: Non-Urgent					
Crossing Status: Found					
UCIP Comments: Pipe appears to be abandoned and should be verified as having been done so properly. - concrete standpipe with 10-inch steel pipe.- concrete wing wall- no pipe- abandoned structure- a pump found on other side of the levee (WS) but not sure whether it is associated with this crossing.					
FIELD_STRUCT_DESC: *ABANDONED* 24-inch gravity drainage pipe of an unknown material under the landside (LS) approach, at an unknown depth. Plans to install a 10-inch corrugated iron gravity drainage culvert under the LS approach, at an unknown depth. Crossing not found in the O&M Manual.					
FS Date: 4/12/2013

LS- overview of landside with concrete standpipe

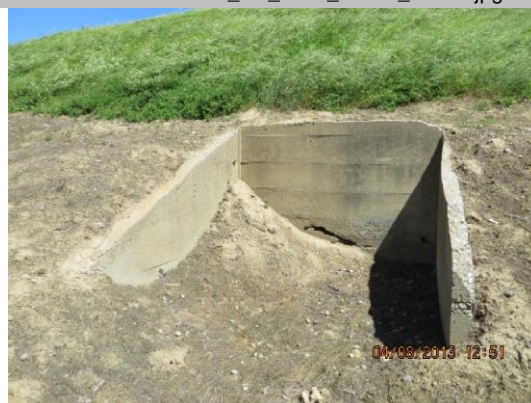
Photo 2 of 3 : UCIP_SP_2018_41787_18792.jpg

Comment Code						
Inspector Comment						
FS_ID:41787						
DS_ID:18667						
EP_NO: N/A						
Repair Type: Non-Urgent						
Crossing Status: Found						
UCIP Comments: Pipe appears to be abandoned and should be verified as having been done so properly. - concrete standpipe with 10-inch steel pipe.- concrete wing wall- no pipe- abandoned structure- a pump found on other side of the levee (WS) but not sure whether it is associated with this crossing.						
FIELD_STRUCT_DESC: *ABANDONED* 24-inch gravity drainage pipe of an unknown material under the landside (LS) approach, at an unknown depth. Plans to install a 10-inch corrugated iron gravity drainage culvert under the LS approach, at an unknown depth. Crossing not found in the O&M Manual.						
FS Date: 4/12/2013

LS- abandoned wing wall- no pipe

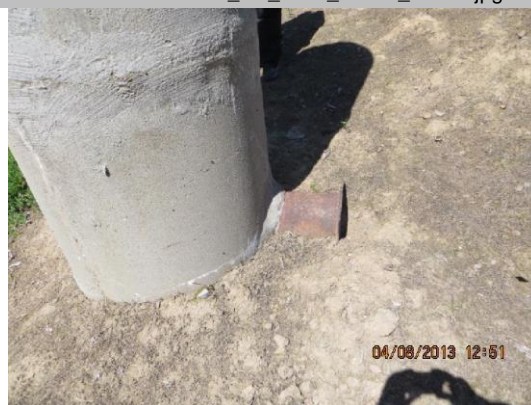
Photo 3 of 3 : UCIP_SP_2018_41787_18791.jpg

LS- concrete standpipe with disconnected steel pipe

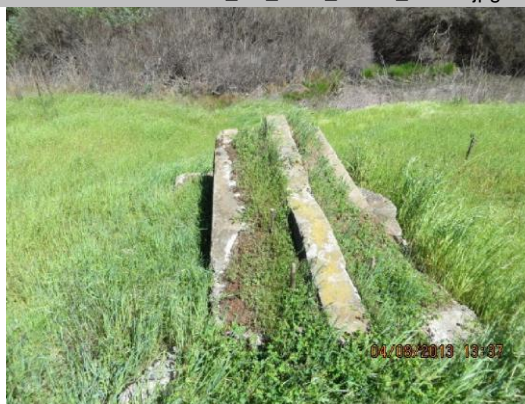
Photo 1 of 3 : UCIP_SP_2018_41348_18882.jpg

Comment Code					
Inspector Comment					
FS_ID:41348					
DS_ID:17918					
EP_NO: N/A					
Repair Type: Non-Urgent					
Crossing Status: Indicator Found					
UCIP Comments: Only an abandoned steel structure on water and a concrete structure on WS Levee slope found. Need to verify pipe was properly abandoned.					
FIELD_STRUCT_DESC: *ABANDONED* 8-inch steel pipe of an unknown purpose through the levee, 4.1 feet below the crown. Siphon breaker on the landside (LS) slope. Butterfly shutoff valve on the LS slope. Concrete standpipe and pump at the LS toe. Pipe discharges into borrow pit on the waterside (WS). [Additional Reference(s): DWR Levee Log, 2005. USACE Sacramento O&M Manual 144, August 1955, (Station 574+20)].					
FS Date: 4/8/2013

WS- abandoned concrete structure on levee slope

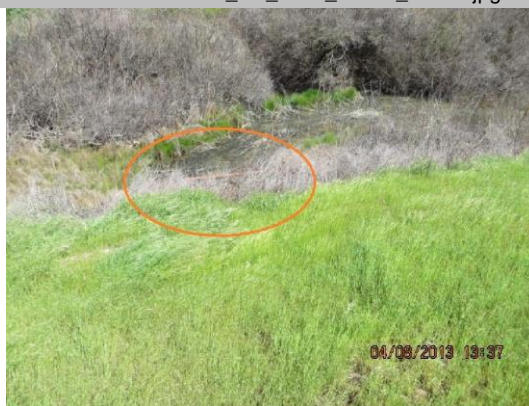
Photo 2 of 3 : UCIP_SP_2018_41348_18881.jpg

Comment Code						
Inspector Comment						
FS_ID:41348 DS_ID:17918 EP_NO: N/A Repair Type: Non-Urgent Crossing Status: Indicator Found UCIP Comments: Only an abandoned steel structure on water and a concrete structure on WS Levee slope found. Need to verify pipe was properly abandoned. FIELD_STRUCT_DESC: *ABANDONED* 8-inch steel pipe of an unknown purpose through the levee, 4.1 feet below the crown. Siphon breaker on the landside (LS) slope. Butterfly shutoff valve on the LS slope. Concrete standpipe and pump at the LS toe. Pipe discharges into borrow pit on the waterside (WS). [Additional Reference(s): DWR Levee Log, 2005. USACE Sacramento O&M Manual 144, August 1955, (Station 574+20)]. FS Date: 4/8/2013

WS- abandoned steel structure on waterway

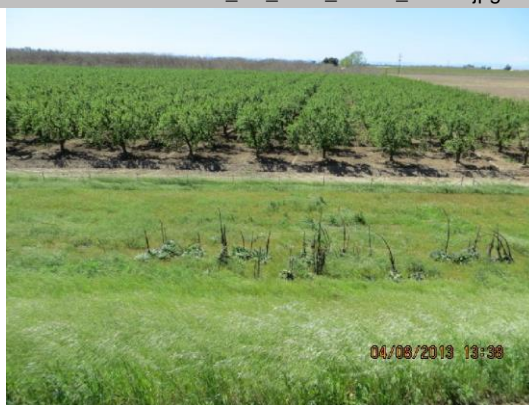
Photo 3 of 3 : UCIP_SP_2018_41348_18880.jpg

Overview of landside of the levee- no pipes visible. Dense vegetation.

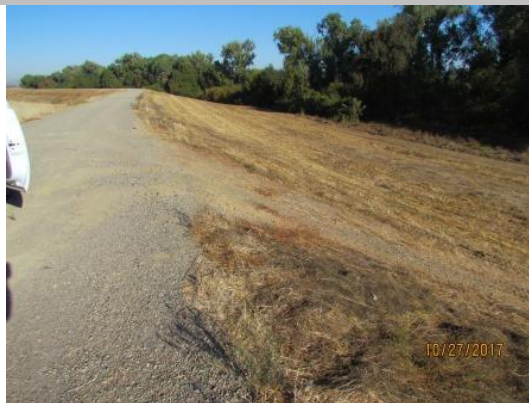
Photo 1 of 2 : SP_2018_LD0001S_433_36_20180302_00015.jpg

LM Start	4.41	Rating **	A/W	Issue No.	36
LM End	4.41	Issue Type +	Ma	Location *	WS
Category	Earthen Levee			GPS Latitude/Longitude	
				Start	End
Item	Slope Stability			39.011493 °	39.011493 °
				-121.603624 °	-121.603624 °
DWR ID	DWR_LD0001S_01_f _ 2016_36				
Comment Code					
S3 : Repair the levee slope damaged by vehicle traffic and prevent access where possible.					
Inspector Comment					
No erosion or separation on slope, continue to monitor, Fall 2017.

View of waterside slope where vehicles have been driving up and down to go around gate. Fall 2017.

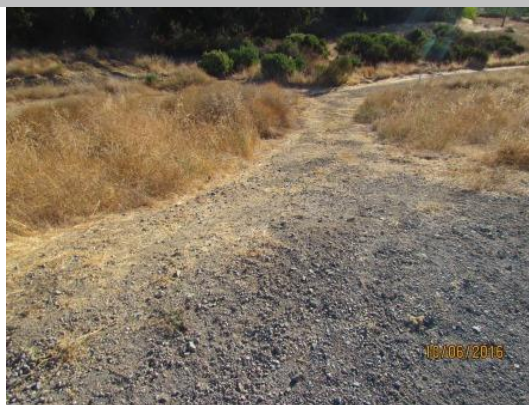
Photo 2 of 2 : SP_2018_LD0001S_433_36_20180302_00016.jpg

View of waterside slope where vehicles have been driving up and down to go around gate. Fall 2016.

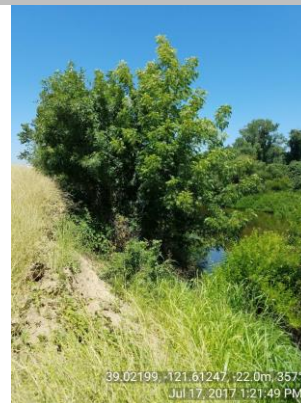
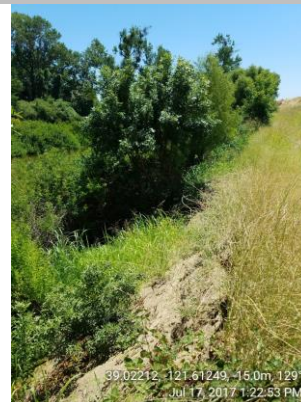
LM Start	5.02	Rating **	A/W	Issue No.	25	
LM End	5.02	Issue Type +	Ma	Location *		
Category	Supplemental			GPS Latitude/Longitude		
				Start		End
Item	2017 Storm Damage			39.018322 °	39.018322 °	
				-121.610275 °	-121.610275 °	
DWR ID	DWR_LD0001S_01_f_2017_25					
Comment Code						
Inspector Comment						
Levee Evaluation Comments						
Description:						
Site ID No:145						
Site Designation:LD1-S-02						
Repair Type: Erosion						
Rating:Critical						
Field Date:7/17/2017						
Notes:

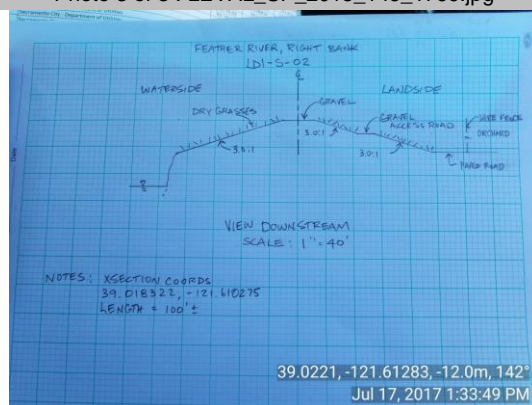
Photo 3 of 3 : LEVAL_SP_2018_145_1769.jpg

LM Start	5.02	Rating **	A/W	Issue No.	25 (cont)	
LM End	5.02	Issue Type +	Ma	Location *		
Category	Supplemental			GPS Latitude/Longitude		
				Start		End
Item	2017 Storm Damage			39.018322 °	39.018322 °	
				-121.610275 °	-121.610275 °	
DWR ID	DWR_LD0001S_01_f_2017_25					
Comment Code						
Inspector Comment						
Levee Evaluation Comments						
Description:						
Site ID No:145						
Site Designation:LD1-S-02						
Repair Type: Erosion						
Rating:Critical						
Field Date:7/17/2017						
Notes:

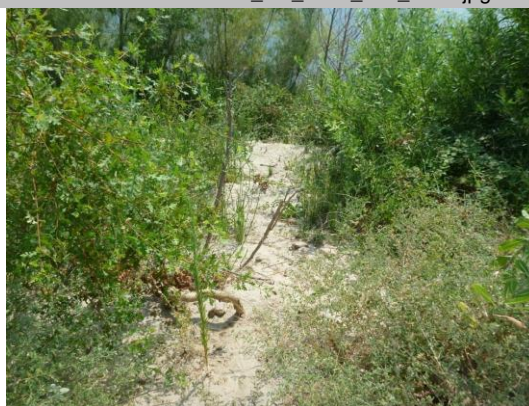
Photo 3 of 3 : LEVAL_SP_2018_146_4054.jpg

LM Start	7.69	Rating **	A/W	Issue No.	19 (cont)	
LM End	7.74	Issue Type +	Ma	Location *		
Category	Supplemental			GPS Latitude/Longitude		
				Start	End	
Item	2017 Storm Damage			39.055986 °	39.056710 °	
				-121.611301 °	-121.611331 °	
DWR ID	DWR_LD0001S_01_f_2017_19					
Comment Code						
Inspector Comment						
Levee Evaluation Comments						
Description:						
Site ID No:146						
Site Designation:LD1-S-03						
Repair Type: Erosion						
Rating:Area of Concern						
Field Date:8/3/2017						
Notes:

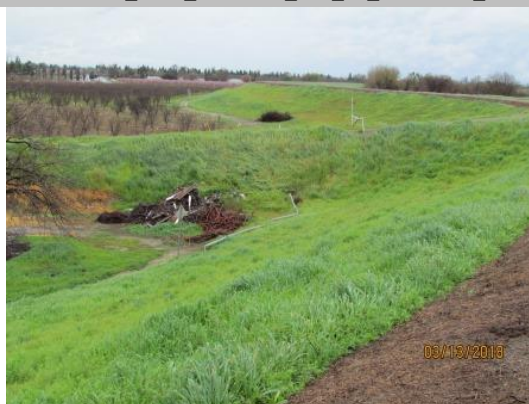
Photo 1 of 2 : SP_2018_LD0001S_433_23_20180319_00063.jpg

LM Start	9.35	Rating **	M	Issue No.	23
LM End	9.35	Issue Type +	En	Location *	LS
Category	Earthen Levee			GPS Latitude/Longitude	
				Start	End
Item	Encroachments			39.079026 °	39.079026 °
				-121.604386 °	-121.604386 °
DWR ID	DWR_LD0001S_01_f_2015_23				
Comment Code					
PR : Prunings					
Inspector Comment					
Tree trimmings and debris still exist at landside toe that are within 10' of the toe need to be removed, Spring 2018.

View of pruning's that still exist on the landside levee toe. Spring 2018.

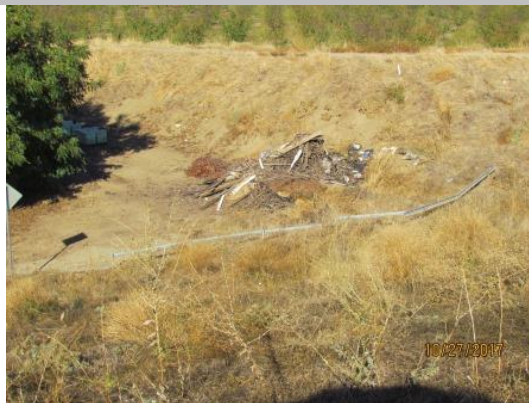
Photo 2 of 2 : SP_2018_LD0001S_433_23_20180302_00007.jpg

View of pruning's on the landside levee toe. Fall 2017.

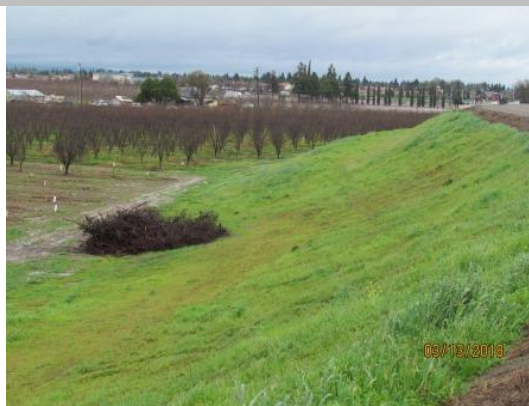
Photo 1 of 1 : SP_2018_LD0001S_433_18_20180319_00064.jpg

View looking upstream of pruning's that are within 10' of the landside levee toe, Spring 2018.

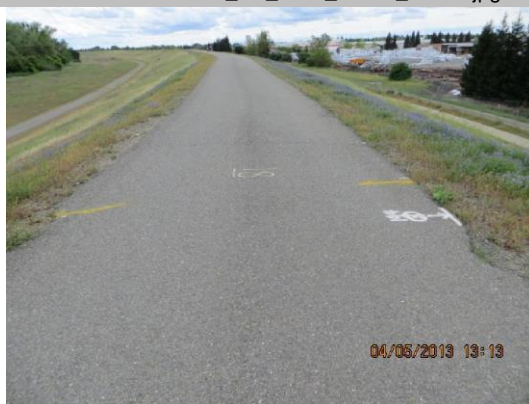
Photo 1 of 3 : UCIP_SP_2018_41841_19538.jpg

LM Start	11.99	Rating **	M	Issue No.	43
LM End	11.99	Issue Type +	En	Location *	
Category	Supplemental			GPS Latitude/Longitude	
				Start	End
Item	DWR UCIP Field Study			39.114856 °	39.114856 °
				-121.605821 °	-121.605821 °
DWR ID					
Comment Code					
Inspector Comment					
FS_ID:41841 DS_ID:17932 EP_NO: N/A Repair Type: Non-Urgent Crossing Status: Indicator Found UCIP Comments: Need to install Gasline Markers.Fenced control station.Indicator on LS across concrete ditch.Found road markings. FIELD_STRUCT_DESC: 1 of 2: 16-inch natural gas pipeline of an unknown material through the levee, 3 feet below the crown. PG&E gas line crossing sign on the waterside (WS) shoulder. [Additional Reference(s): DWR Levee Log, 2005]. FS Date: 4/5/2013

Levee Crown: gasline indicator/markings on crown road.

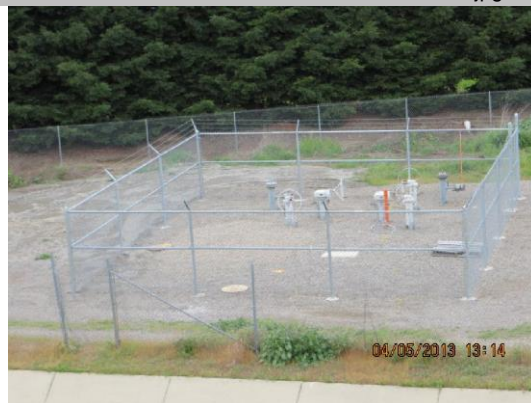
Photo 3 of 3 : UCIP_SP_2018_41841_19534.jpg

LS- fenced control station with indicators

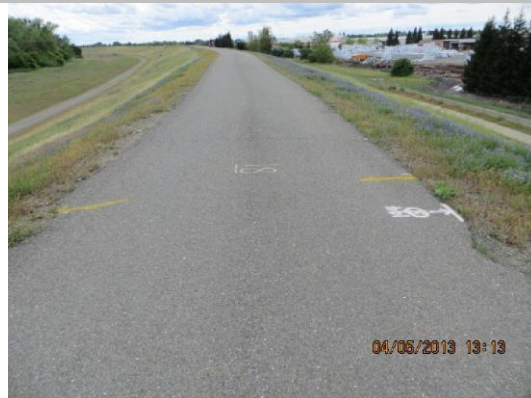
Photo 1 of 3 : UCIP_SP_2018_41889_19566.jpg

LM Start	12.00	Rating **	M	Issue No.	44
LM End	12.00	Issue Type +	En	Location *	
Category	Supplemental			GPS Latitude/Longitude	
				Start	End
Item	DWR UCIP Field Study			39.114856 °	39.114856 °
				-121.605821 °	-121.605821 °
DWR ID					
Comment Code					
Inspector Comment					
FS_ID:41889 DS_ID:18880 EP_NO: N/A Repair Type: Non-Urgent Crossing Status: Indicator Found UCIP Comments: Need to contact owner to install gasoline markers.Fenced control station on LS.Indicator on LS across concrete channel.Road markings. FIELD_STRUCT_DESC: 2 of 2: 16-inch natural gas pipeline of an unknown material through the levee, 3 feet below the crown. PG&E gas line crossing sign on the waterside (WS) shoulder. [Additional Reference(s): DWR Levee Log, 2005]. FS Date: 4/5/2013

Levee Crown: road markings on road pavement

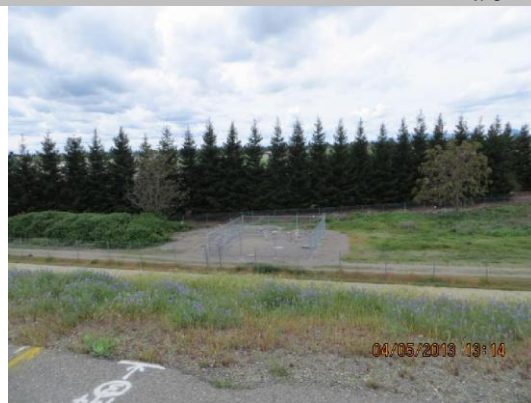
Photo 2 of 3 : UCIP_SP_2018_41889_19565.jpg

LS- fenced control station across concrete ditch.

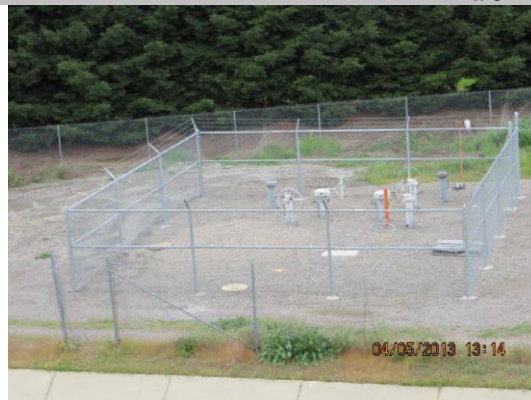
Photo 3 of 3 : UCIP_SP_2018_41889_19564.jpg

LS- fenced control station with gasoline indicator across concrete ditch.

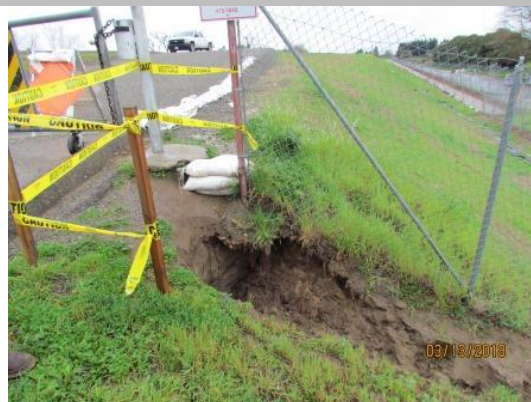
Photo 1 of 4 : SP_2018_LD0001S_433_31_20180319_00066.jpg

View of erosion from run off at a ramp. This will be repaired with the punch list for the completion of the project, Spring 2018.

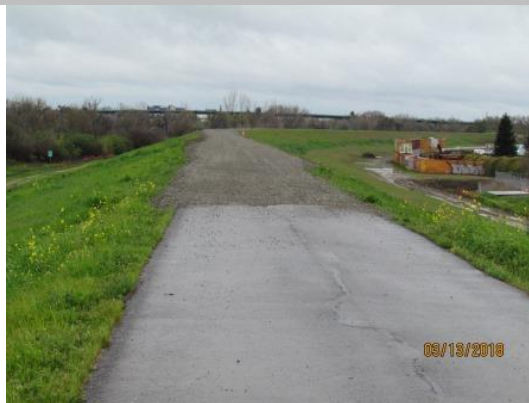
Photo 2 of 4 : SP_2018_LD0001S_433_31_20180319_00067.jpg

View looking downstream. This section of levee is still under construction, It has been brought up to grade and the bike path needs to be paved, also a few more punch list item finished up before it is turned over to the LMA, Spring 2018.

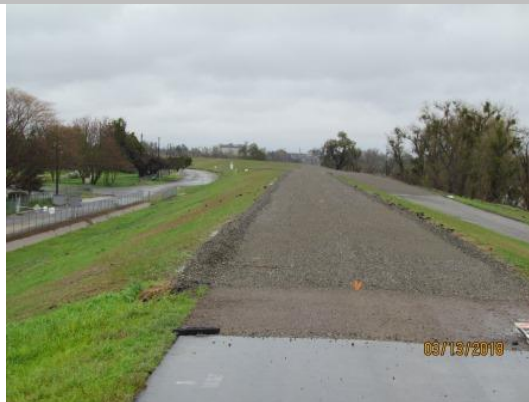
Photo 3 of 4 : SP_2018_LD0001S_433_31_20180319_00068.jpg

View looking upstream. This section of levee is still under construction, It has been brought up to grade and the bike path needs to be paved, also a few more punch list item finished up before it is turned over to the LMA, Spring 2018.

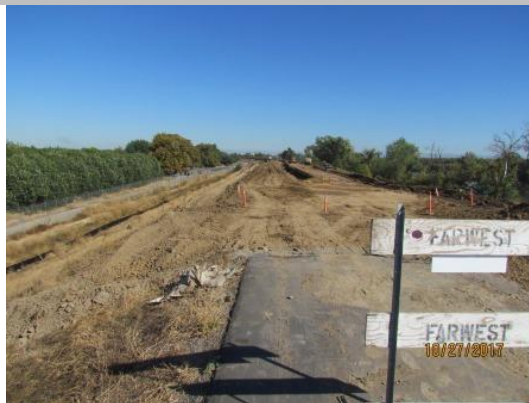
Photo 4 of 4 : SP_2018_LD0001S_433_31_20180302_00011.jpg

View looking upstream at the start point of the new construction of the levee, Fall 2017.

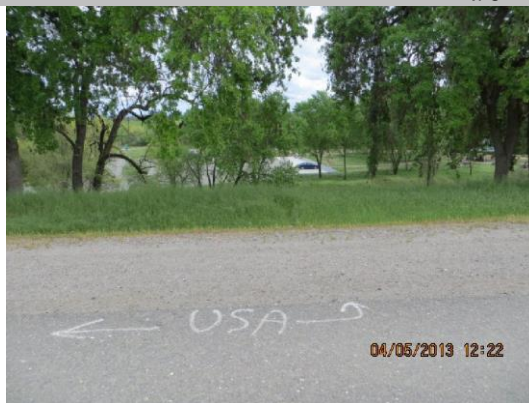
Photo 1 of 3 : UCIP_SP_2018_41887_19571.jpg

WS- USA road marking and floodway area

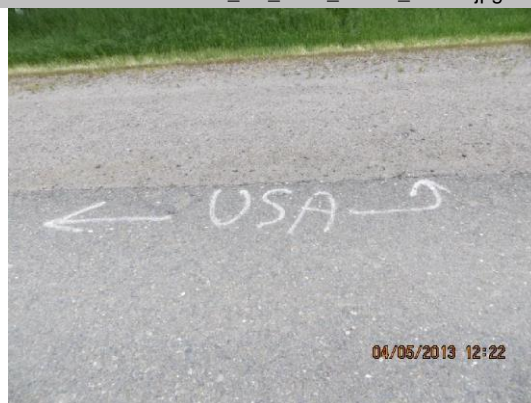
Photo 2 of 3 : UCIP_SP_2018_41887_19570.jpg

WS- USA road marking on pavement

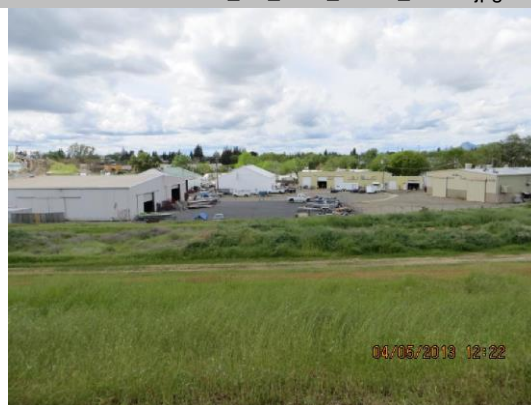
Photo 3 of 3 : UCIP_SP_2018_41887_19569.jpg

LS- overview. No sign post or indicator found.

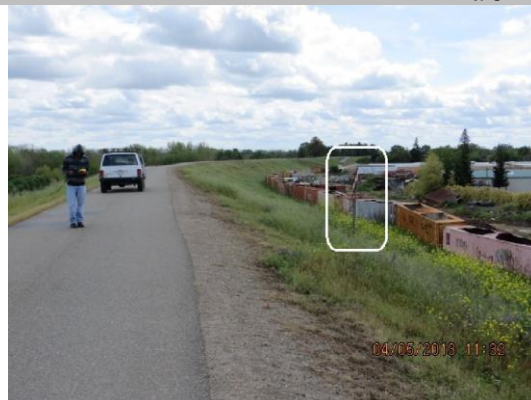
Photo 1 of 2 : UCIP_SP_2018_12092_19624.jpg

LS- overview of gasline marker on levee slope

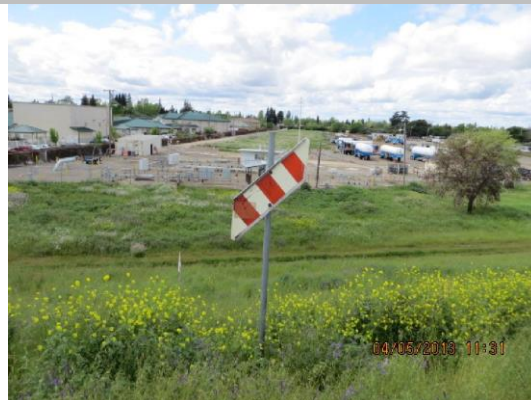
Photo 2 of 2 : UCIP_SP_2018_12092_19623.jpg

LS- gasline marker on levee slope

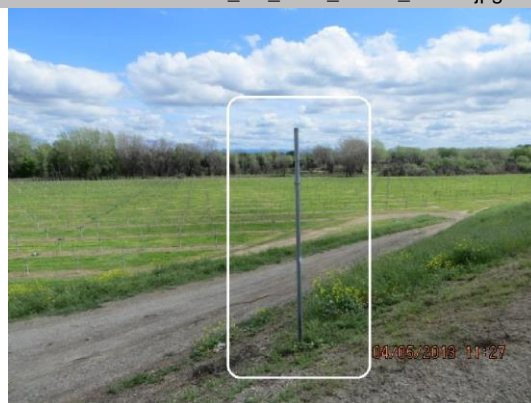
Photo 1 of 3 : UCIP_SP_2018_12104_19642.jpg

WS- needs a gasoline indicator.

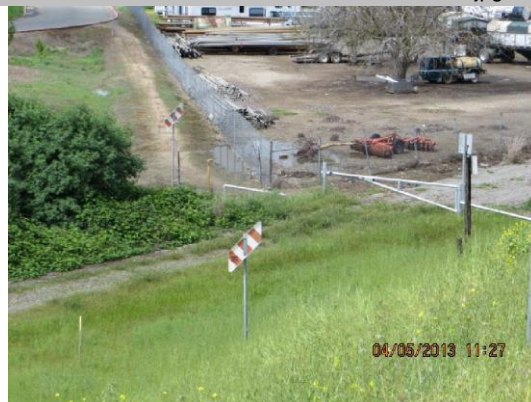
Photo 2 of 3 : UCIP_SP_2018_12104_19641.jpg

LS- gasoline indicators on levee slope and across.

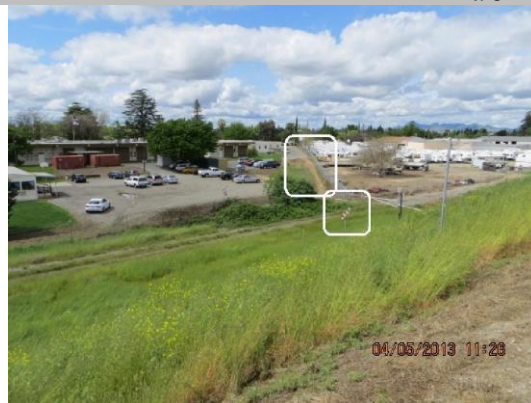
Photo 3 of 3 : UCIP_SP_2018_12104_19640.jpg

LS- overview of gasoline indicators on levee slope and across.

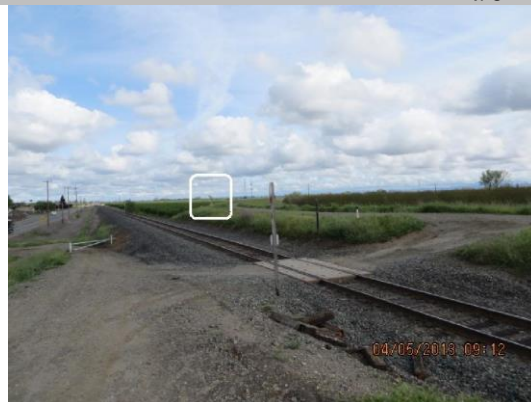
Photo 1 of 2 : UCIP_SP_2018_41888_19709.jpg

Railway and levee crossing and gasoline sign across the railway

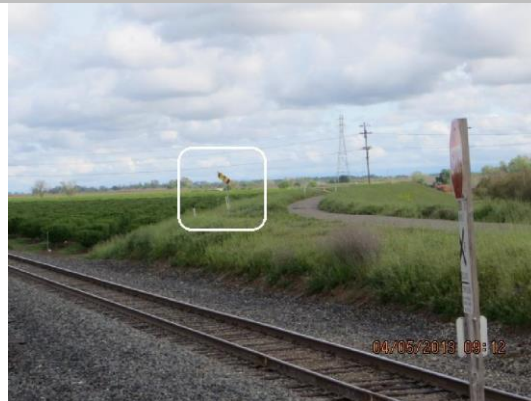
Photo 2 of 2 : UCIP_SP_2018_41888_19708.jpg

Gasline sign across the railway
